## **XIIth Winter Report 1995-96**

S A KANE

R & D E (Engineers), DRDO, Pune 411015

### **Abstract**

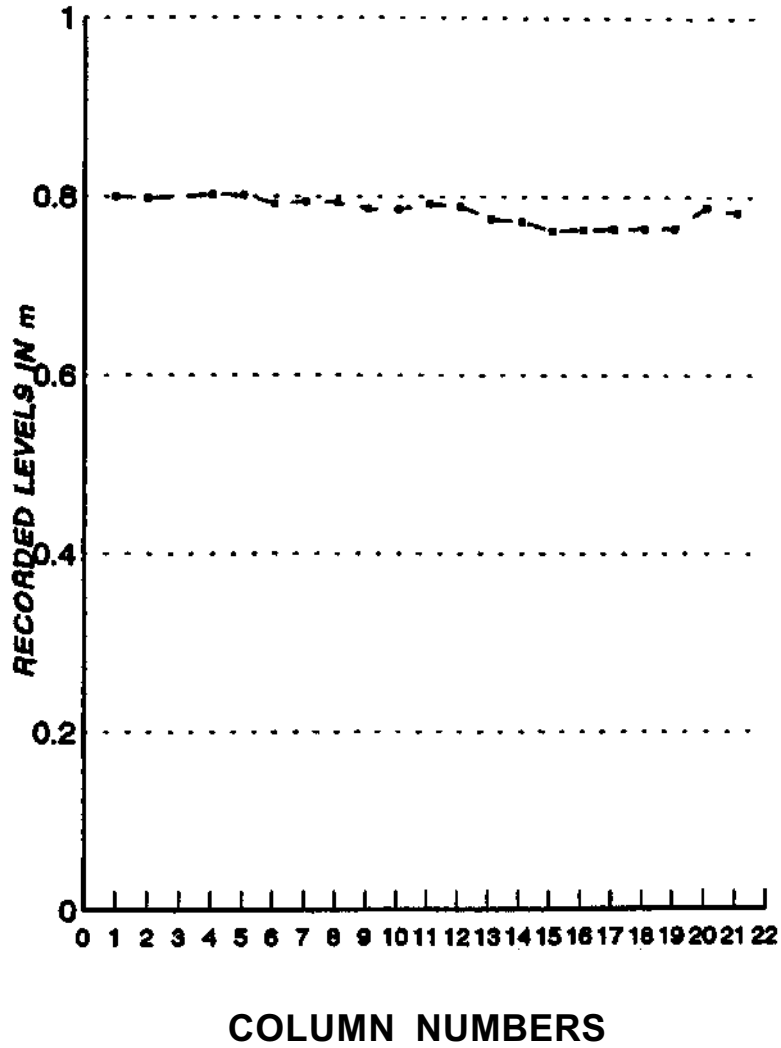
PLATE I

near the front door of the luonge in 'B' Block and the levels of the top column plates were observed which are given at Appendix 'C' and are plotted at pl. I.

9.2. It is observed that the maximum difference between the levels of the top plates of the columns is 0.04 m which is within the acceptable limits. This may be as a result of initial settlement of columns due to self weight and live loads imposed during installation.

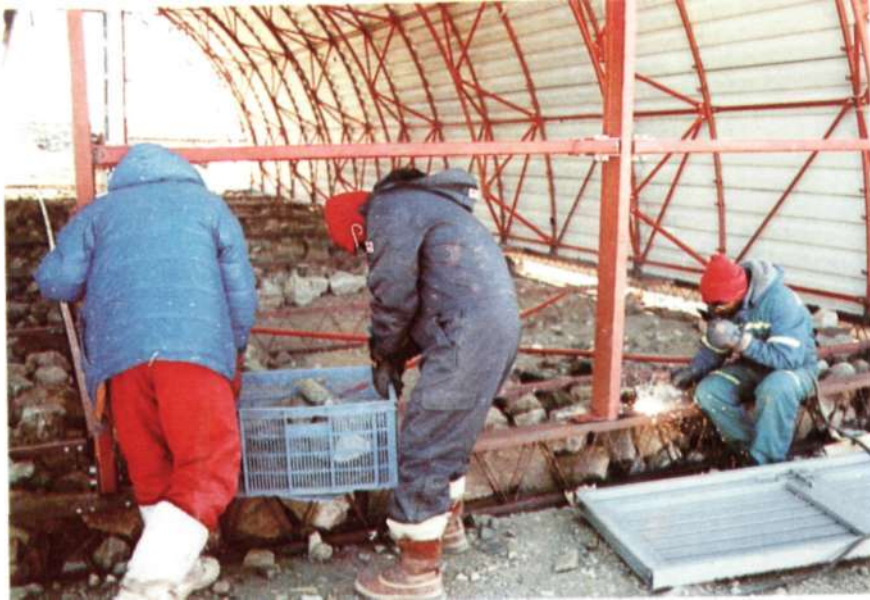
**5. WELDING AND FILLING OF FOUNDATION**

with the entire work explaining the drawings, methodology and sequence of operation. Welding of all the junctions of the cross and longitudinal Floor Girders and the joints of Arches and Floor Girders was carried out to give additional strength and to prevent any relative movement between them.

5.9 **Filling of Foundation and Concreting:** The foundation of the structure was filled with stones, prior to concreting. This required collection of approx, 120 cu m of stones and more than 300 man hours. Concreting of the floor of size 20 x 9 x 0.05 m was done upto the top level of the Floor Girder at an ambient temperature of +5 to +6 degree C in January 1996.

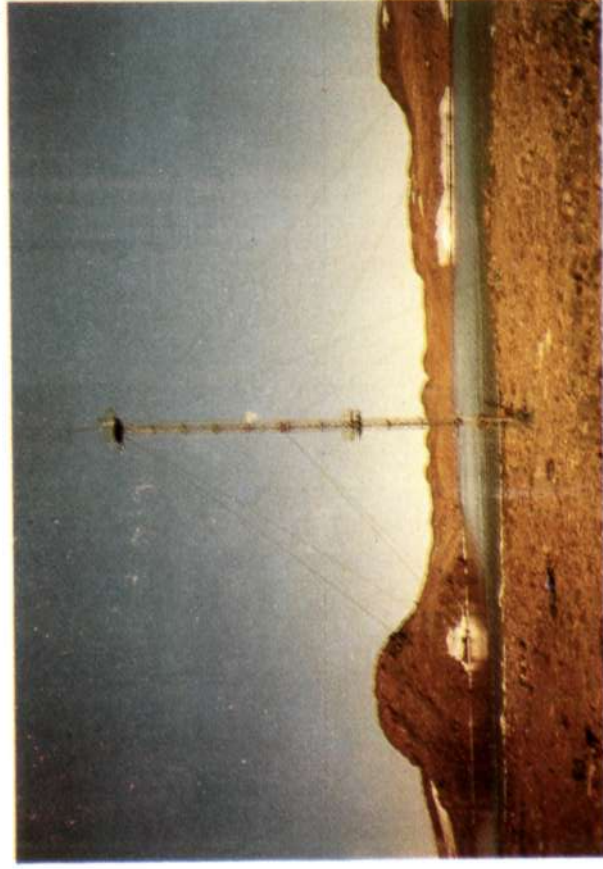
9. 28 M MAST

9.4 Visual inspection of the 28 m mast could be done only upto a height of 2 to 2.5 m from the ground. It was revealed during inspection that no external damage to the mast as well as the guy ropes was noticed. However, at some places rusting of the rope had taken place. The tension in some of the wire ropes was required to be adjusted and was done as and where required.

- (d) The stability of the 28 m mast depends on good condition of the wire ropes. These ropes are designed and manufactured for use at normal working conditions. However, in Antarctica, these are subjected to sub-zero temperatures and high winds over number of years and as such are prone to be fast deteriorated. It is not possible to check the hidden defects like inner breakage of strands and rusting of core by visual inspection.

- (c) It is suggested that working life of the guy ropes of 20 m mast under present Antarctic conditions be assessed and action to replace these ropes be taken accordingly.
