ELECTRICAL EARTHING AND ELECTROSTATIC PROTECTION AT ANTARCTICA

R.N. Sarwade and P.K. Dey

Research & Development Establishment (Engineers)

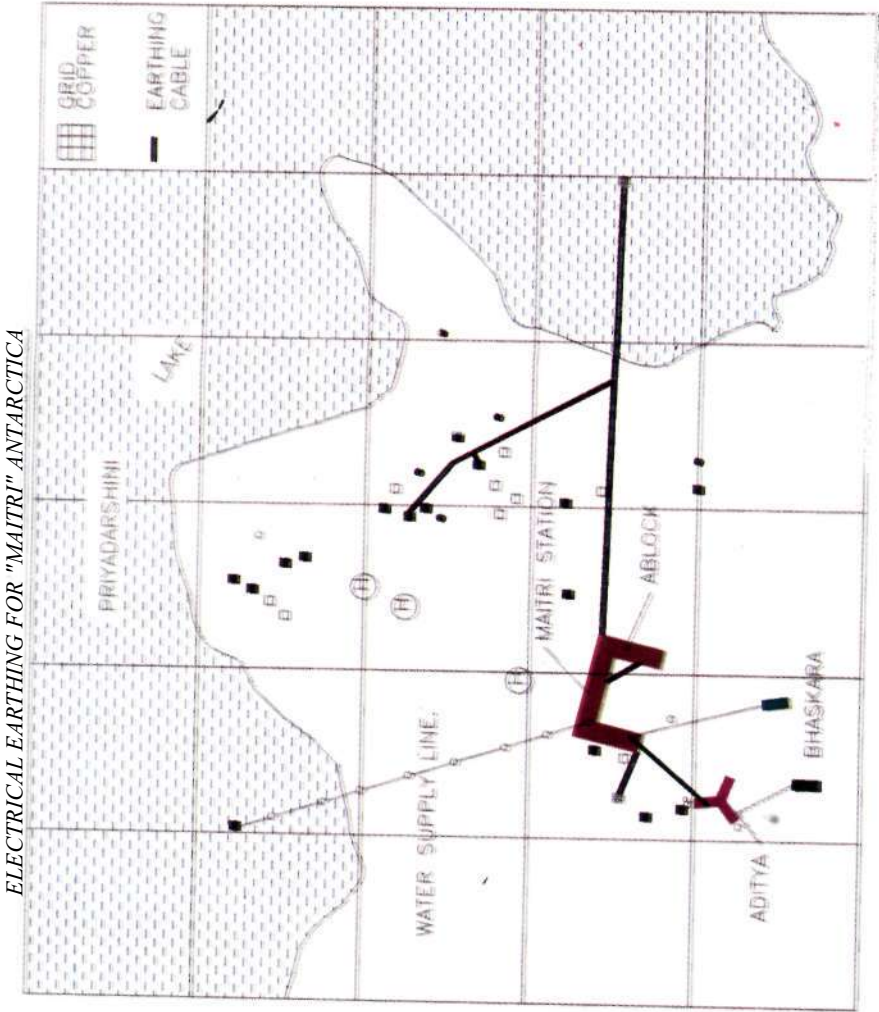
Fig.1

One more cage was fabricated in the same manner as above and was lowered in the waste water ditch. This in turn was connected to the foundation columns, (**Fig.1**). The electrical potential difference measured successively after each of the above steps, gradually decreased from 80 V to 45 V to 25 V, and finally to 1.5 V. It was continuously monitored even during winter.

The cage dropped in kitchen waste water ditch was nearer to the boundary of the ditch. In winter, the freezing of water starts from boundary. Soon after the time when water in the vicinity of the cage was completely frozen, increase in potential difference between ground to neutral was noticed. Further inspection lead to the following findings:

- Braided copper used for connecting the cage to main ground was corroded due to sulphadising.
- Many joints on the way were found to be corroded.
- Ground connection to Bhaskara power block was found to be broken.

- Copper cage was shifted from boundary to the centre of the ditch and after excavation of ice, the cage was lowered to the bed of the ditch and was covered with a mixture of coal, salt, sand.

- The buried cage was connected to main ground (foundation columns of the station) with a thick copper strip, instead of braided copper as earlier.
- All the joints were cleaned and properly connected.
- New earthing cable was laid, connecting Bhaskara power block with the main ground.

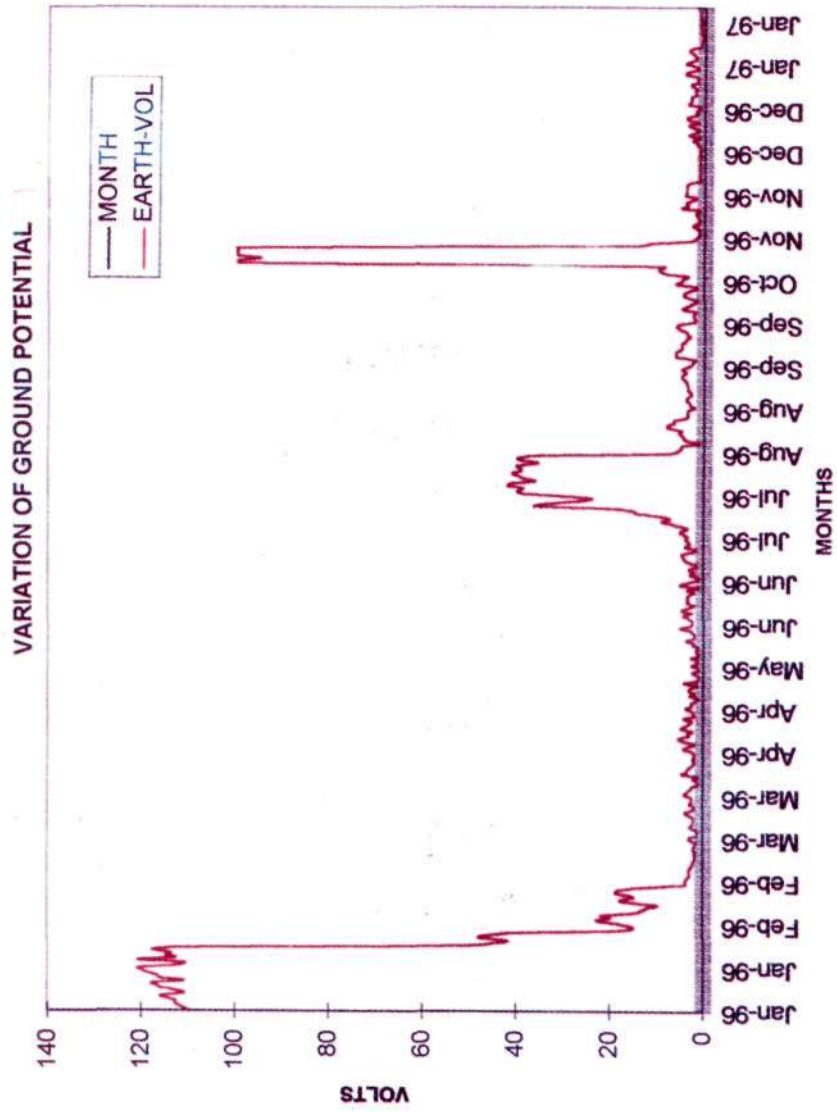
The difference in ground and neutral potential was measured regularly. **Chart-1** shows its variation over the year. It is clearly seen that till Feb 96, the difference was 100 V plus. The earthing was provided in Feb 96, as described. The chart shows rise during July-Aug 96. It is seen, (**Charts-2,3,4**), the minimum temperature is - 42°C around 21st July 96, due to which water around the cage was totally frozen and the result was increased potential difference during July and August, of the order of 40 V. The rise in ground potential during Oct-Nov 96 is due to mechanical failure of the laid cable.
