## **Report on the Logistic Activity Carried out by the 20<sup>th</sup> Indian Antarctic Expedition**

**Maj Atul Apte**

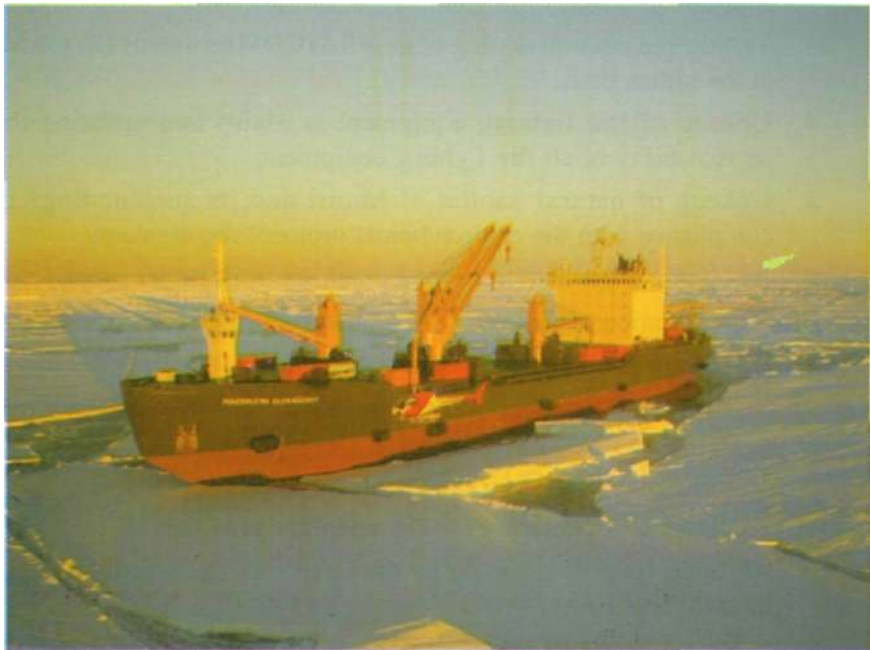
Fig. 1: Helicopter operation being carried out from Ship M V Magdalena Oldendorff.

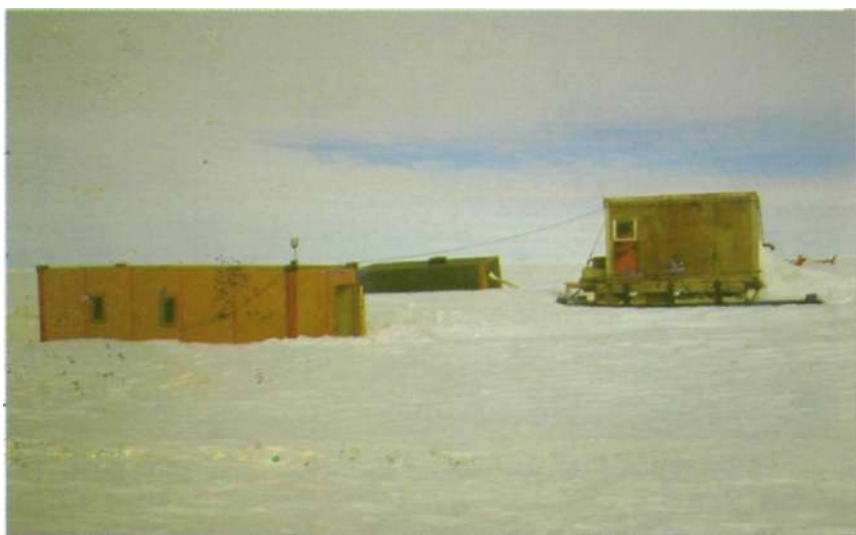
Fig. 2: Location of IIG summer camp at DG

**Establishment of Dakshin Gangotri Summer Camp:** a summer camp was established at the Dakshin Gangotri station site for Indian Institute of Geomagnetism (Fig. 2). This involved overhauling a 30 Kva generator lying unused at DG station site and relocating the living module. A Mantis crane located at DG station site was made operational.

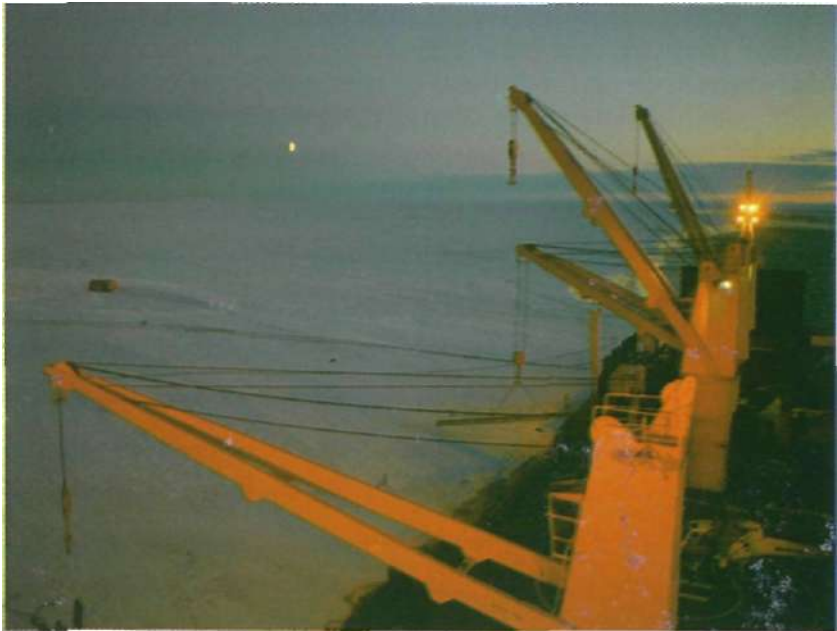
**Problems faced:** The ship was able to discharge the fuel at some distance from the shelf edge into the storage tankers. Offloading cargo containers was very risky as it involved working on the shelf edge as the Ships crane length was less and the cargo could only reach up to the shelf edge (Fig. 3).

*Fig. 3: Ship on shelf-notice the crane size reaching just the shelf edge.*

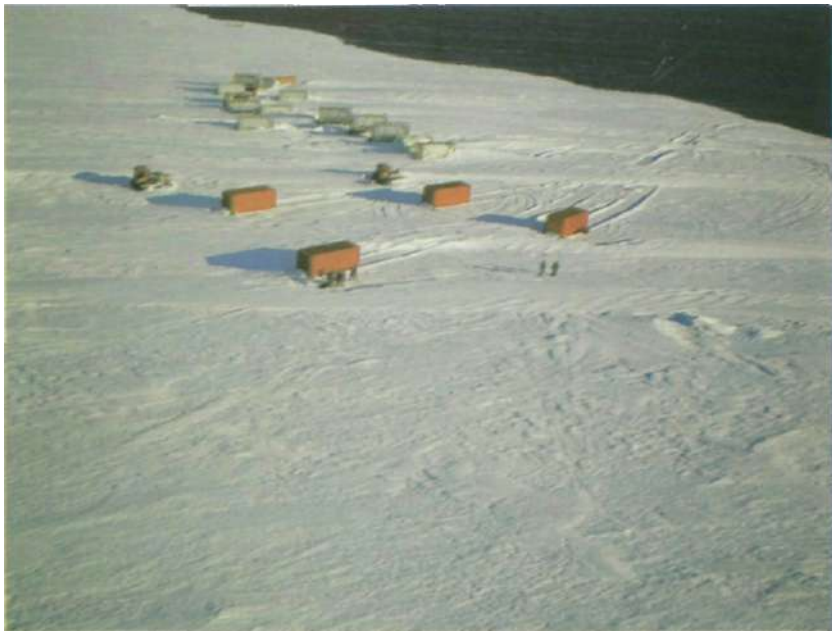
**Cargo handling on the ship:** All cargo, which had been brought by the ship, was off loaded onto the ice shelf (Fig. 4). This included stores, fuel, food and other essential items necessary for the survival of the winter over team during the winter months.

*Fig. 4: Fuel in tankers and cargo in containers lying on shelf.*

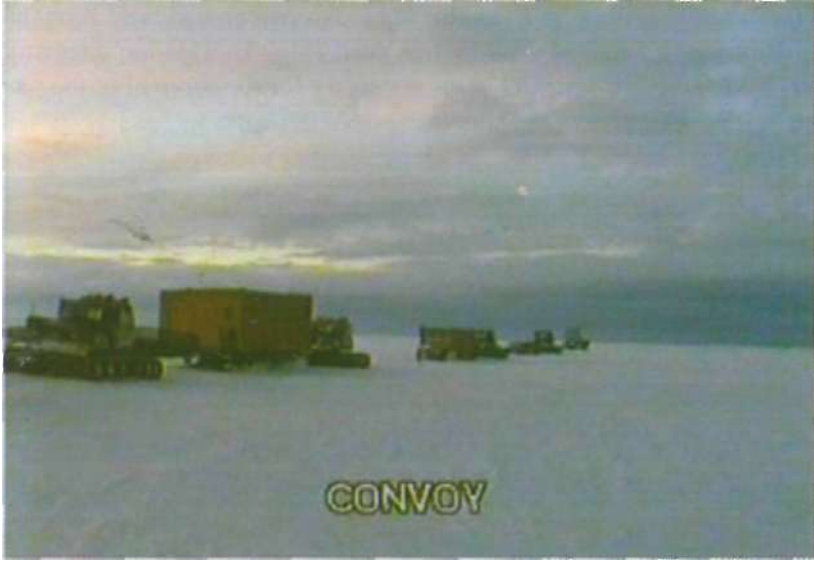
**Convoys:** A total of 11 convoys (Fig. 5), were run from Maitri to DG/ Shelf in the winter period. All the cargo including fuel was shifted to Maitri by these convoys. The containers with items to be back loaded were also taken from Maitri and placed on the ice shelf. All the 20K1 fuel tanks were placed at shelf, for receiving of the fuel from the new team on arrival. Details of the convoys, and convoy route are given in Appx B & C.

*Fig. 5: A convoy heading for shelf*

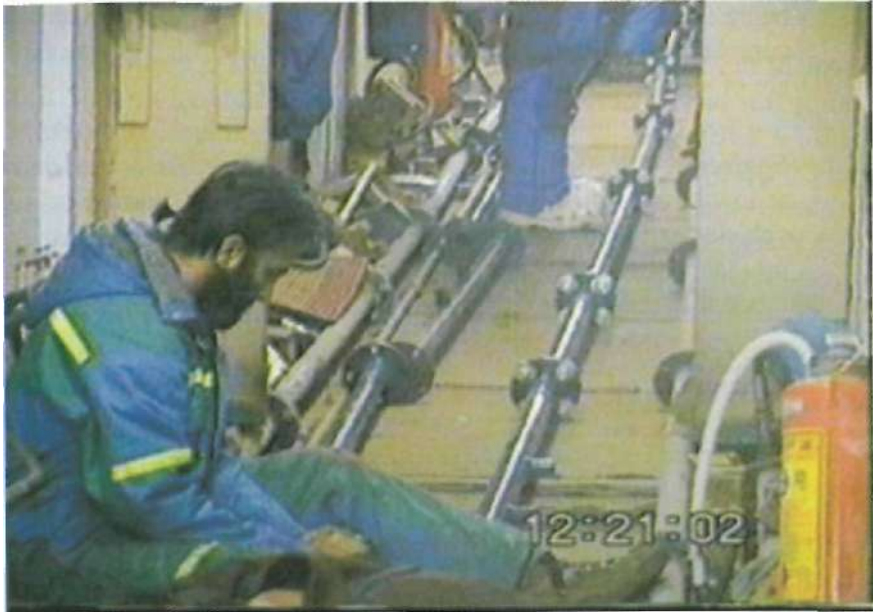
**Replacement of Pipelines of the Station Heating System:** This team was given the task of replacing the old pipeline used for heating the station. The old pipeline was totally corroded (Figs 6 & 7) over the period of time. It was a very important task as it involved basically shutting down of the Boilers and involved removal of entire Deck Boarding of the lobby, disassembling the old pipes and replacing them suitably. This all was to be done at a great speed and with accuracy, as otherwise the station heating would have got affected and caused considerable discomfort to members. The task was immaculately planned and with the help of all members was executed and completed in just 24 hours.

*Fig. 6: Hot water pipeline being replaced.*

**Problems faced:** It was found that the Pipes that had been sent did not confine to the existing pipe layout. As no accurate drawing of the layout was perhaps available in India; the pipes were not exact replacements and keeping practicality in mind the new pipes were laid with minor modifications

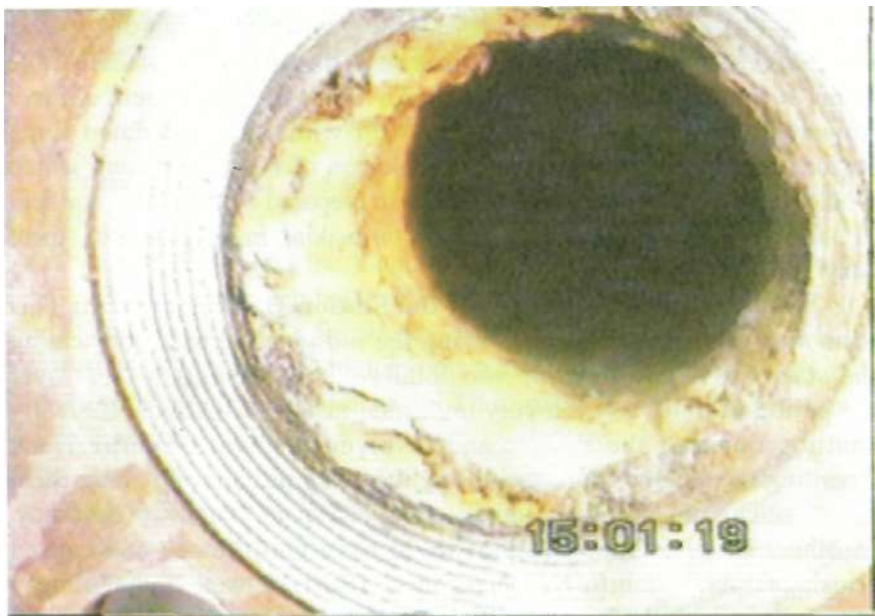
*Fig. 7: The corroded old hot water pipe.*
